Technical Assessment for the CPC FD-7x-1500 Wind Turbine Located at Tooele Army Base, Tooele, Utah

August 2012

**Idaho National Laboratory
Idaho Falls, Idaho 83415**

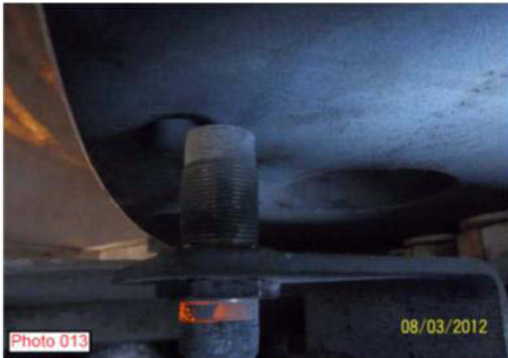
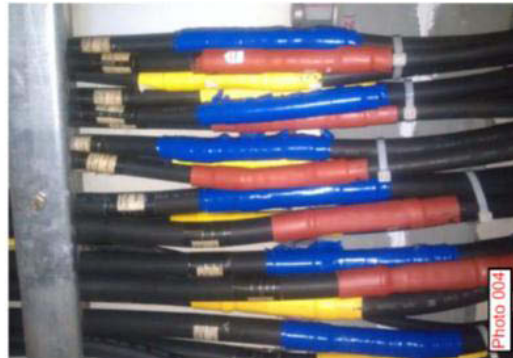
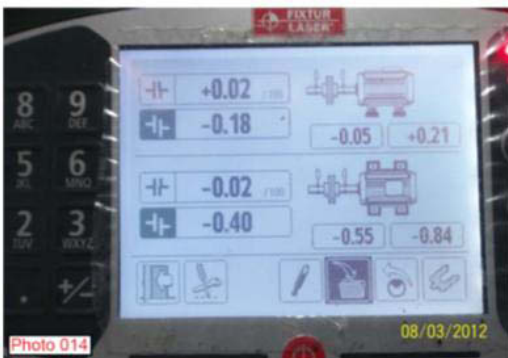
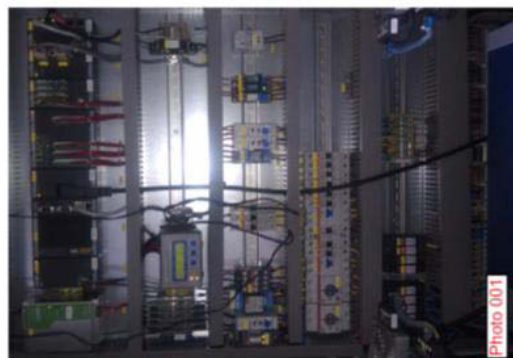
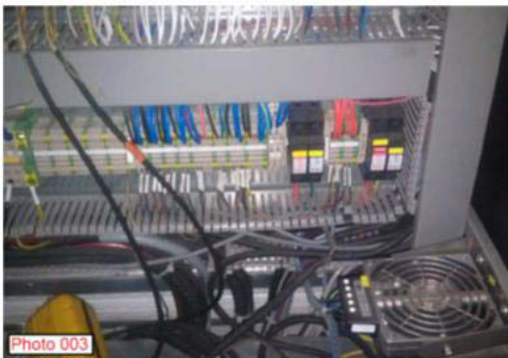
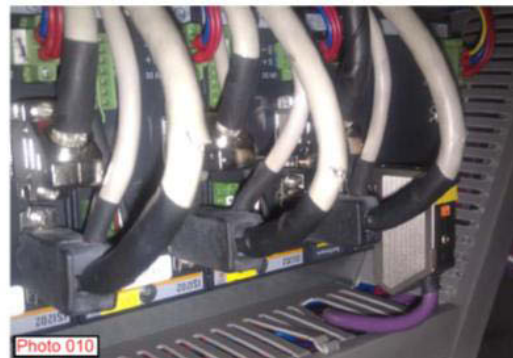
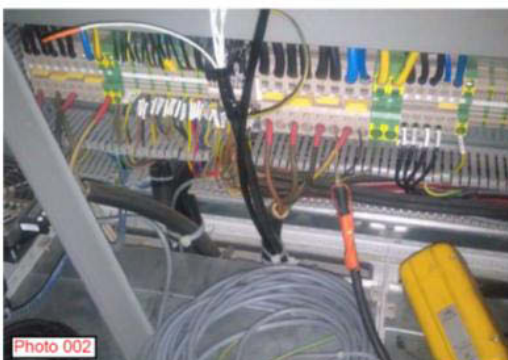
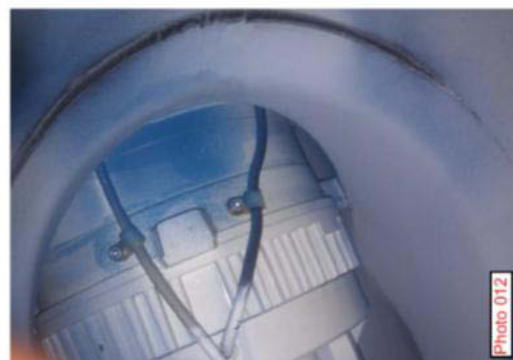
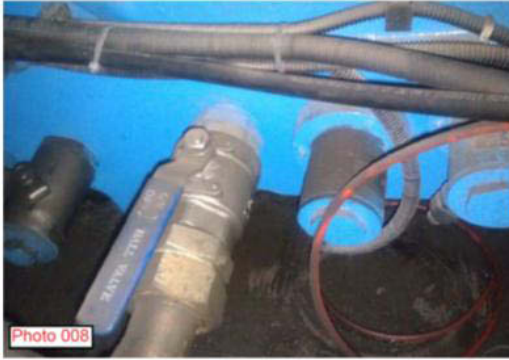
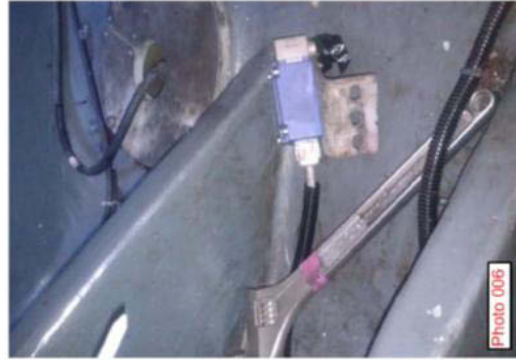
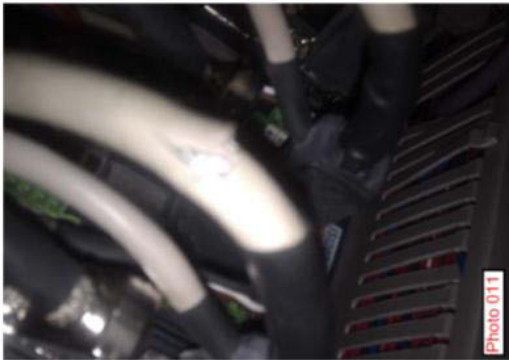
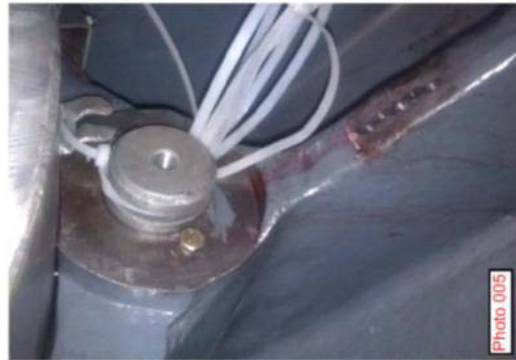
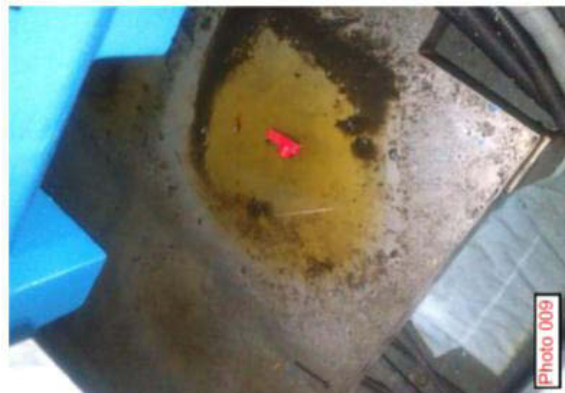
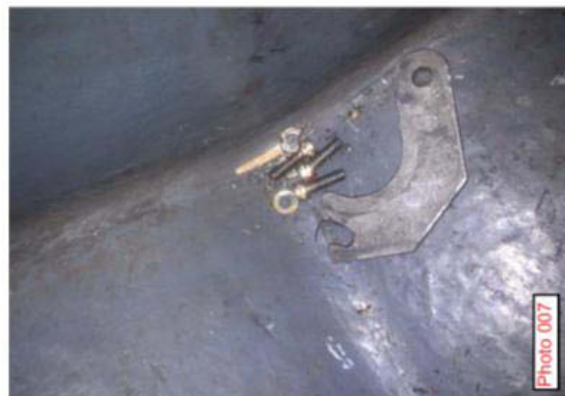
The inspection team found the turbine to be in generally good shape. The Down Tower Assembly looked good and intact. The team checked all cabinets and saw some rewiring done in the Main Control Cabinet and the Top box Cabinet; photo #001, #002, and #003. The Tower section and platforms also looked good, although there were a few bolts on the platforms and platform door hinges that need to be replaced or tightened. The cables going up-tower also looked to be in good shape; photo #004. The Nacelle is in good shape, but did find the rotor lock missing which was later found in a shed with turbine spare parts; the rotor lock shaft was bent and had to be lathed to temporarily fit back in to lock the rotor for hub work; photo #005, #006, and #007, and also see additional photos. A new rotor lock shaft is supposedly on order, so should be fully replaced and installed in the future.

The high-speed brake caliper had leaked at some point, techs found hydraulic fluid on the tray underneath the gearbox; photo #008 and #009. The hub is in good shape overall. The team did find wires inside the center pitch control box with cracked and peeling insulation and a loose connection, the team taped the wires with electrical tape and fixed the connection; photo #010 and #011. The turbine faulted on PCS errors (codes “Pcs Any Error”, “Pcs Failure A”, and “Pcs Failure B”), which after 15 min. the turbine reset itself and started up. The team found one of the pitch motor cooling-fans to be jammed inside its casing which caused the pitch motor to overheat

and fault out the pitch controller. The team repaired the cooling fan; photo #012. The turbine had a fluctuating rotor speed rpm, the team cleaned and adjusted the rotor speed sensor which fixed the issue; photo #013. The team performed a Generator alignment check and found the generator to be well within tolerance; photo #14.

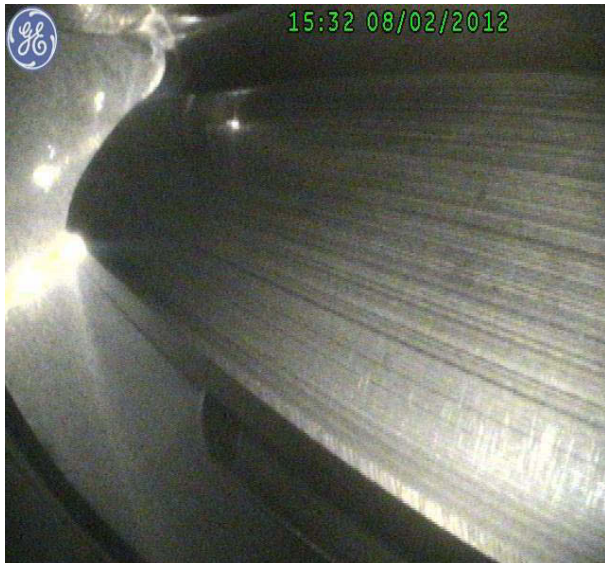
Intermediate Pinion Picture 5

A Borescope was also performed on the gearbox and found some potential issues or problems to be watched over time.
